PRELIMINARY LEACHATE AND GAS

MIGRATION STUDY

DUNDAS LANDFILL SITE

PROJECT No: 79-25

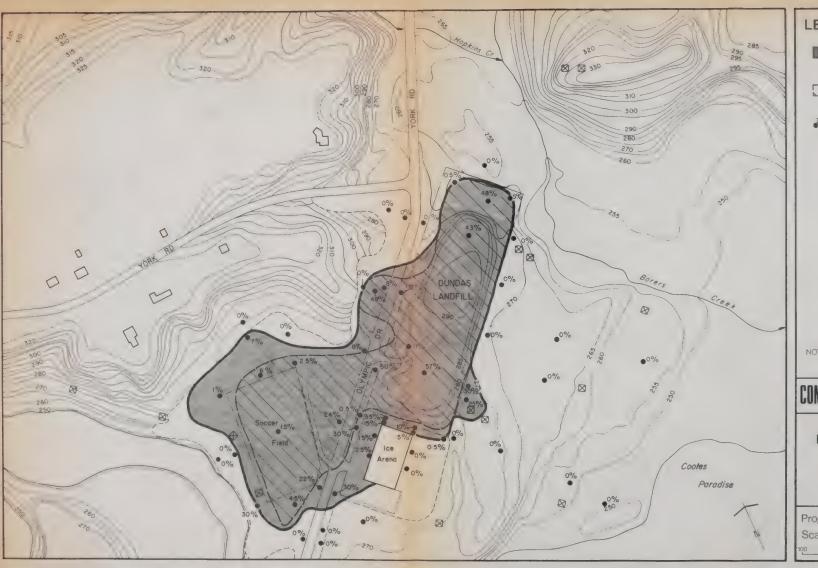
LANDFILL SITE: Based on all available data and our geological field reconnaissance survey, the area of waste disposal was delineated and is shown on map 2, 'Physical Setting'. Waste extends beyond the lands formally designated the Dundas Landfill Site, with a significant zone to the west. The waste was originally disposed of in former gravel pits, but may have subsequently included natural ground. Boreholes drilled by others indicate that the waste may be in the order of 15 to 20 feet deep maximum. Only nominal soil cover was observed on the Dundas Landfill Site itself; however there appears to be 3 to 5 feet of clay cover in the area of the
